High Potential Incident – Electric Shock from a Caddy Welder

Site: Mount Carlton

Date: 21 / 01 / 2013

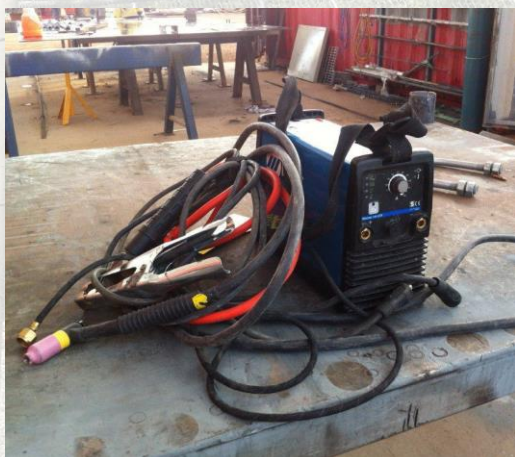
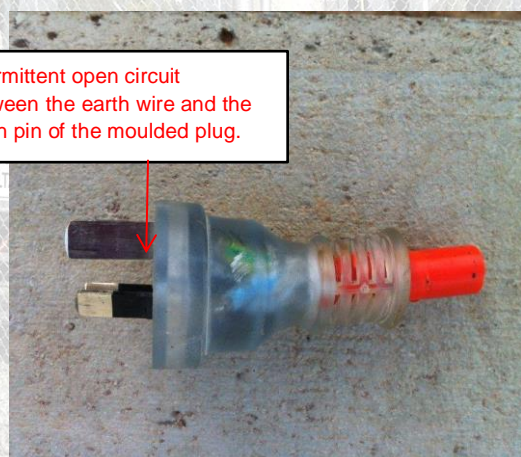
A worker whilst holding an earth lead sustained a mild shock to his right hand from a portable Caddy Welder, he continued working after placing the welder on to a platform ladder and received a 2nd mild shock. A second person also received a mild shock when he placed the earth clamp of the welder on to steel pipe work.

- There was a break in the main supply earth in the moulded plug which caused the frame and the leads to rise to 110 V AC. This is due to a capacitive noise filtration circuit on the secondary side of the isolation transformer
- Shock was similar to that of an electric fence
- Recalled all Caddy welders and found they behave the same way under the same fault condition
- All moulded plugs were replaced on Caddy welders
- All earth continuity checks were tested & recorded

- To report incidents as soon as they occur, this would have prevented the additional two electric shocks occurring.
